**United States Coast Guard  
Office of Investigations and Casualty Analysis  
Safety Alerts, Safety Advisories, Lessons Learned  
2008-2012**

**United States Coast Guard**  
**Office of Investigations and Casualty Analysis**  
**Safety Alerts, Safety Advisories, Lessons Learned**  
**2008-2012**

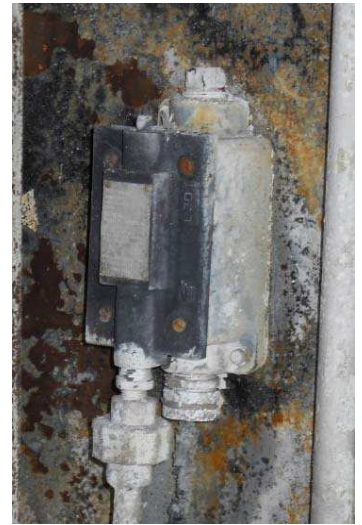
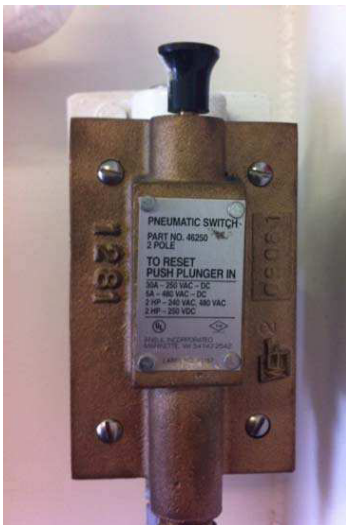
Recently, a vessel with an installed fixed CO<sub>2</sub> fire suppression system, suffered extensive damage due to a fire that started in the engine room. During the firefighting efforts the crew reported that the engine room ventilation could not be secured. A post casualty damage survey of the vessel revealed that the pressure switch used to secure the ventilation was located within the engine room. See the photograph of the damaged pressure switch at the right and new switch below.

Fixed CO<sub>2</sub> systems on inspected/regulated vessels need to be type approved and installed in accordance with applicable regulations; 46 CFR 25.30-15, 46 CFR Subpart 76.15, 46 CFR Subpart 95.15, 46 CFR 118.410, etc. These regulations require all controls and valves for the operation of the system to be outside the space protected, and notes they cannot be located in any space that might be cut off or made inaccessible in the event of fire in the protected spaces. The Coast Guard considers pressure switches that are used in such systems a "control."

The Coast Guard **strongly reminds** Owners and Operators of vessels with installed fixed fire suppression systems to ensure that these switches are properly located aboard their vessels. If the pressure switch or switches are located within the space being protected, they should be relocated by a properly trained fire suppression service technician. Doing so will assist in ensuring system functionality and accessibility in the event of an emergency. Failing to do so could have serious consequences to the vessel, its crew and the environment.

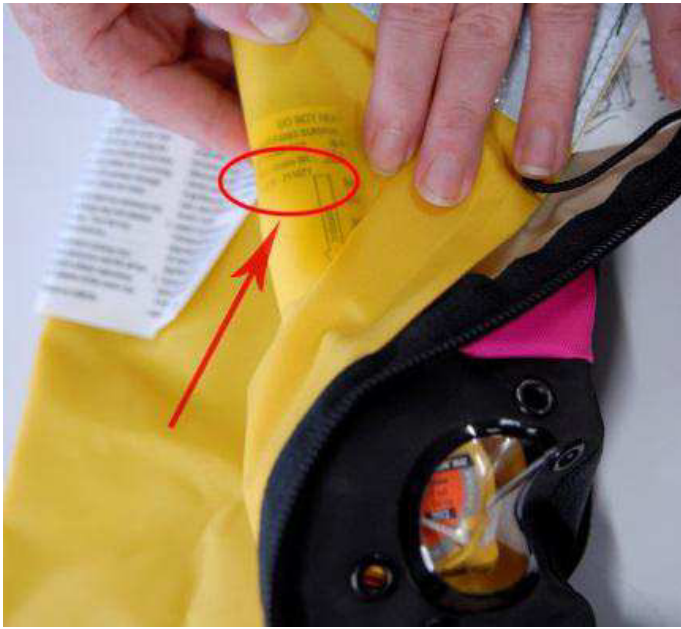
Photograph showing view of lot number through fabric.

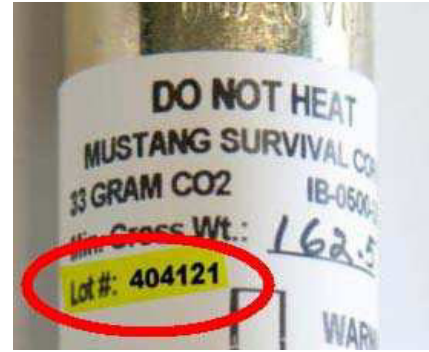
Lot number on cylinder label.

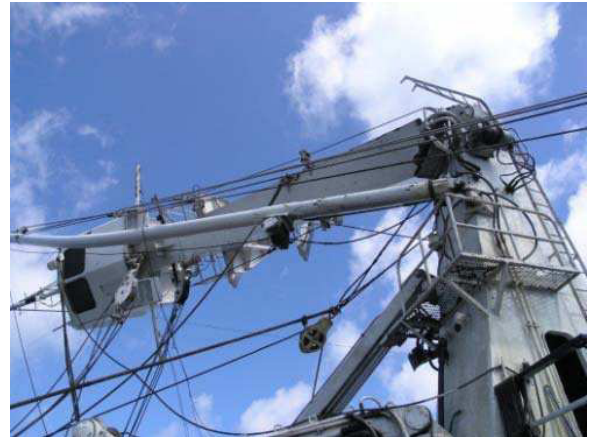
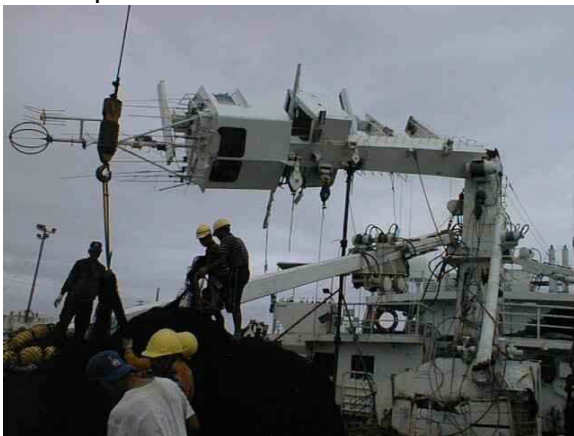
Recently, several catastrophic failures of masts, booms, and lift cables have occurred on purse seine fishing vessels that have resulted in loss of life and severe injuries. Over the years many casualties have occurred onboard all types of fishing vessels attempting to haul in catches that exceeded the capacity of their winches, hoists, and associated equipment. These types of casualties are not unusual. This alert serves to remind all purse seine fishing vessel owners/operators and other fishing segments to ensure safe use of the haul equipment particularly matching the size and the capacity of the nets to the rated size and capacity of the winch/haul/hoist equipment, taking into account safety factors for various species, and other concerns such as the variable platform that a rolling fishing vessel and variable catch presents.

- Know the design limits of load bearing structures and winches, hoist, and haul components;
- Ensure they are not modified by crew members; properly maintained; and are inspected and tested on a regular basis. Repair/replace components immediately when deficiencies are discovered;
- Evaluate and revise operational procedures as needed.

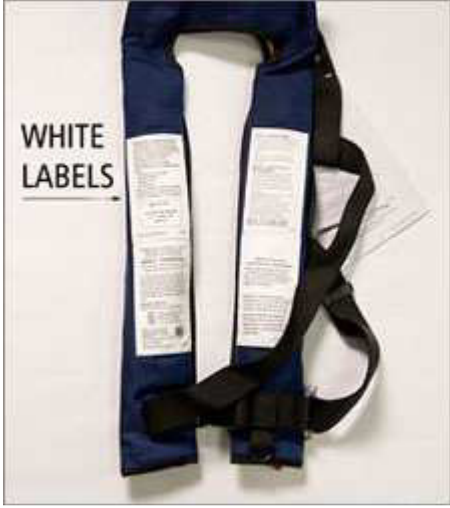
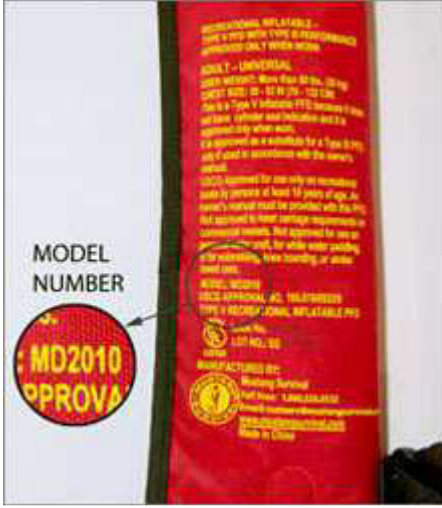
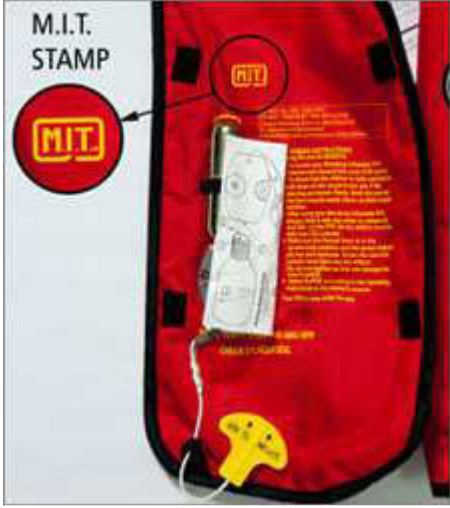
<p><b>Image 1</b> Product with white labels are <u>not</u> part of this recall.</p>	<p><b>Image 2</b> Check for the model number on the back of the PFD above the UL logo.</p>	<p><b>Image 3</b> Any MD2010 or MD2012 with an "MIT" stamp is OK to use and does not need to be returned.</p>

This recall is being issued for the inspection and repair of an inflator installation inconsistency that may prevent some units from fully inflating with CO2 (oral inflation functions normally). Mustang Survival has developed a solution that corrects any affected product and prevents re-occurrence of this issue. The inspection and repair can only be performed at a Mustang Survival factory.

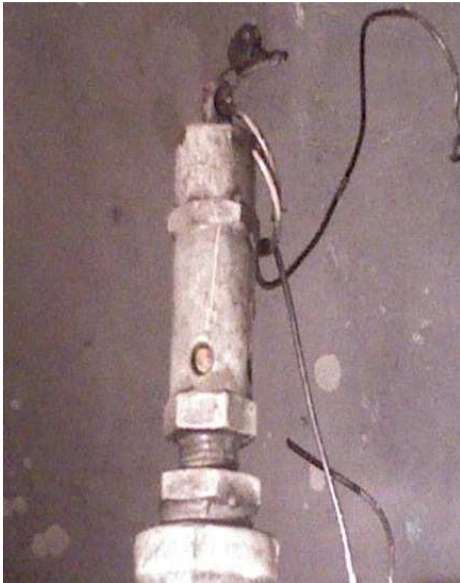
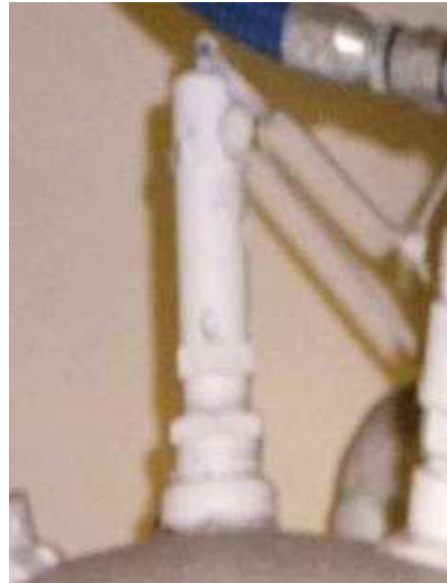
- Pressure relief devices are not capable of being isolated or their operation prevented by being wired or secured in a position that prevents the valve from opening;

**RELIEF VALVES MUST NEVER BE SECURED IN THE CLOSED POSITION**

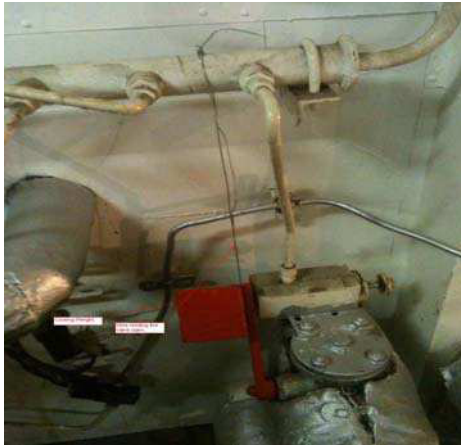
QCV blocked utilizing wire to hold closing weight up and the valve in the open position.

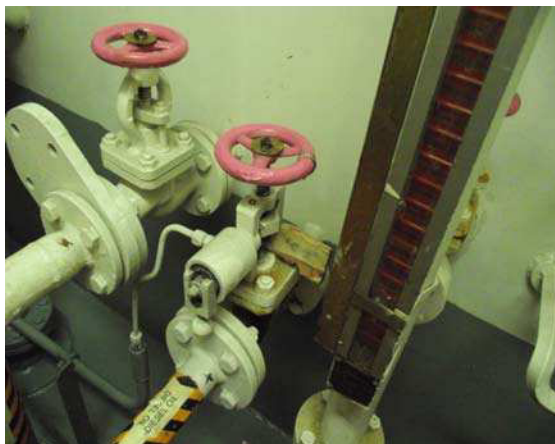
QCV blocked utilizing a wooden block to hold the valve in the open position.

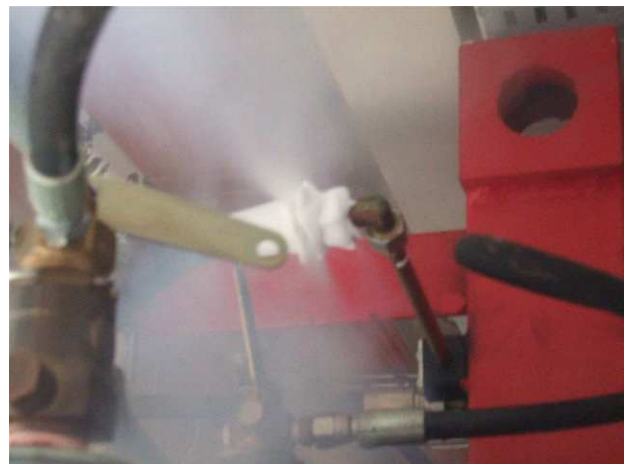
- Numerous piping and hose connections leaked extensively. When the system was activated, on scene video taken by the firefighters showed numerous leakages into the CO2 room. Post casualty, while pressure was still on the system, some of these leaks continued even after the connections were tightened. (Photograph at right.)

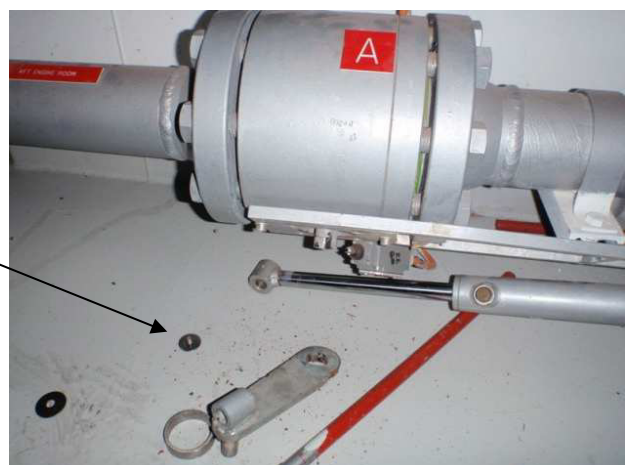
- The zone valve for the aft machinery space which admits CO2 from the bottle bank manifold to the space failed. Specifically, the ball valve's opening actuating arm fell off the valve when the gas powered piston actuator attempted to move it. The ball valve actuating arm was held in place by a very small machine screw and washer. When firefighters attempted to open the valve manually using the provided hardware it could not be moved. The valve was only able to be moved after the gas pressure was relieved from the inlet side of the valve. (Photograph at right.)

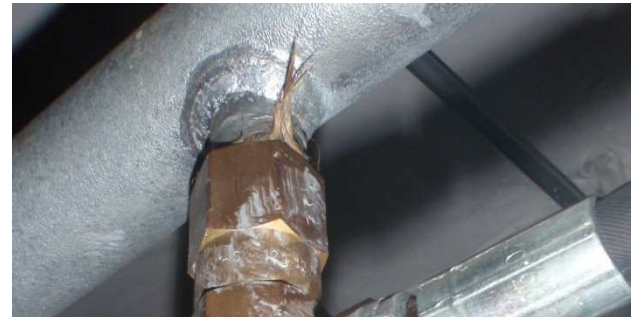
- Hemp type pipe sealant was used extensively on pipe threads throughout the system and in some instances seems to have entered the system. (Photograph at right.)

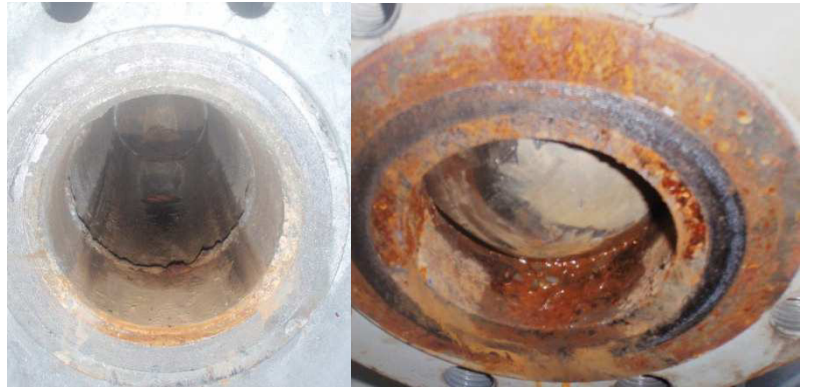
- Certain elements of the distribution manifold contained low points which allowed the accumulation of water within piping that could not be drained. Such a circumstance could cause corrosion that could possibly negatively effect operation of other components. (Photographs at right.)

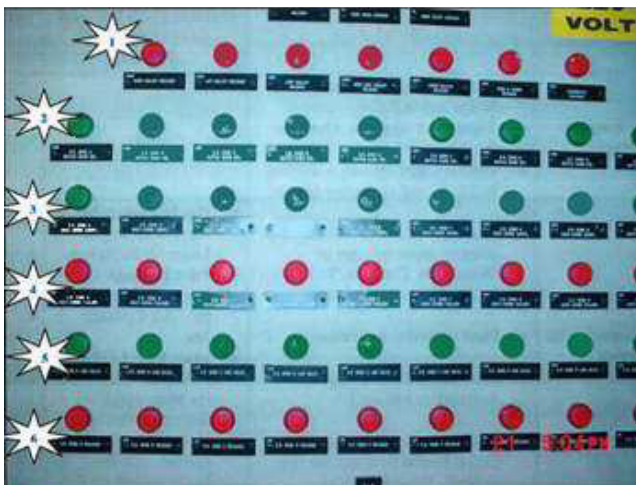
- Shipyard commissioning test procedures appear to differ from procedures documented in the vessel's Firefighting Instruction Manual (FIM). Commissioning procedures indicate that the discharge line selection to a specific protected zone should be made prior to releasing the gas contrary to the directions in the FIM.
- The FIM refers extensively to a Control Panel (left following image) that differs vastly from the one onboard the vessel (right following image).

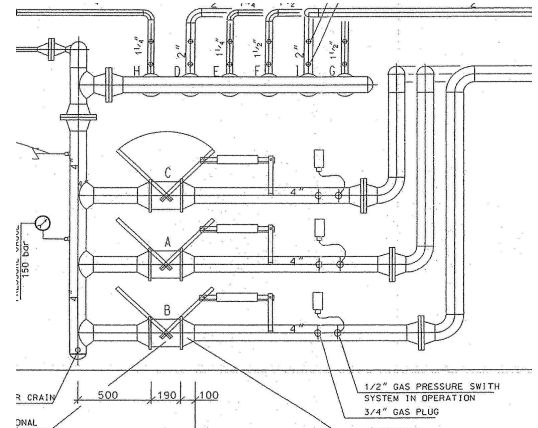
- Shipyard piping schematics and drawings do not appear to match the actual installation. The schematic at the right shows the “A valve” for the Aft Machinery Space in the center position vice the bottom position as it is installed on the vessel.

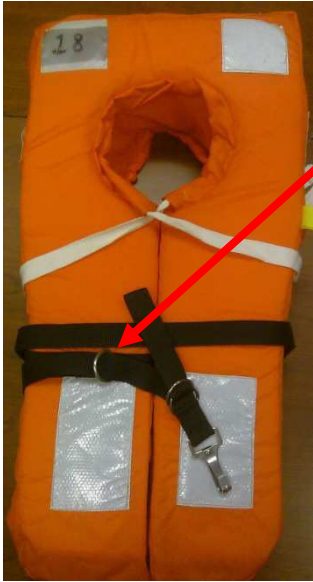
Recent Coast Guard inspections of Type I Personal Flotation Devices, (PFDs) in both adult and child size, identified a potential hazard that could prevent proper donning in the event of an emergency. The chest strap was threaded through the fixed "D" ring that the strap is intended to clip to when worn. *(Image left)*

The Coast Guard **strongly recommends** that vessel owners/operators using the PFDs listed above check each lifejacket for proper routing of the strap. Completely unwrap the primary strap to ensure it is free and capable of being adjusted for any wearer. The strap of the lifejacket must not be threaded through the fixed "D" ring. If routing is satisfactory, the strap may be wrapped around the life jacket and clipped to the fixed "D" ring for storage. *(Right image)* If the strap is incorrectly threaded through the fixed "D" ring, the snap hook assembly should be carefully removed from the strap, the strap pulled out of the fixed "D" ring, and the snap hook assembly re-attached.

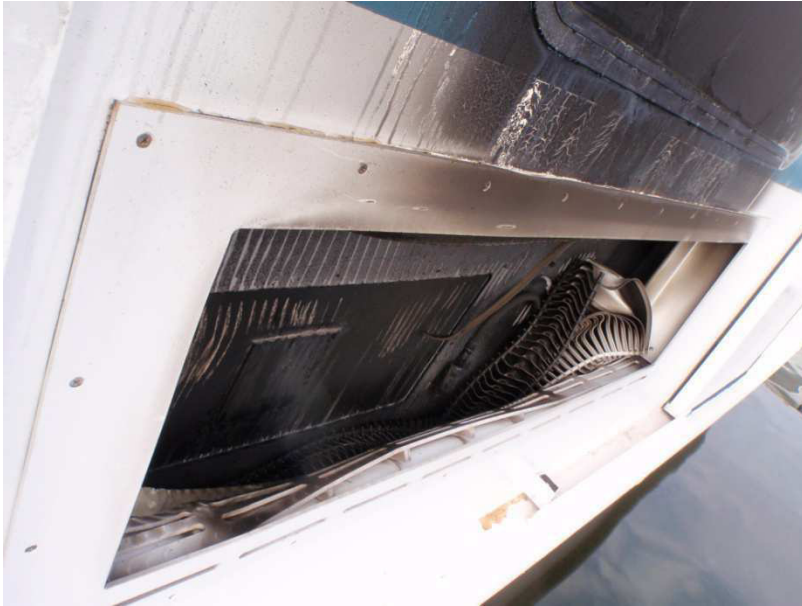
noted that *if* the filter had melted and fallen on or into the slot of the duct before the damper closed, it is likely to have interfered with the damper operation and possibly have reduced the effectiveness of the CO2 system.

46 CFR 116.610 (b) applicable to this vessel, states that “a ventilation duct, and materials incidental to installation must be made of noncombustible material.” 46 CFR 116.610(c) states that “combustibles and other foreign materials are not allowed within ventilation ducts. However metal piping and electrical wiring installed in a metal protective enclosure may be installed within ventilation ducts, provided that the piping or wiring does not interfere with the operation of fire dampers.” Owners and operators of any type vessel, as well as those persons involved with the inspection of vessels should be aware of the potential risks associated with this and similar installations and are reminded that

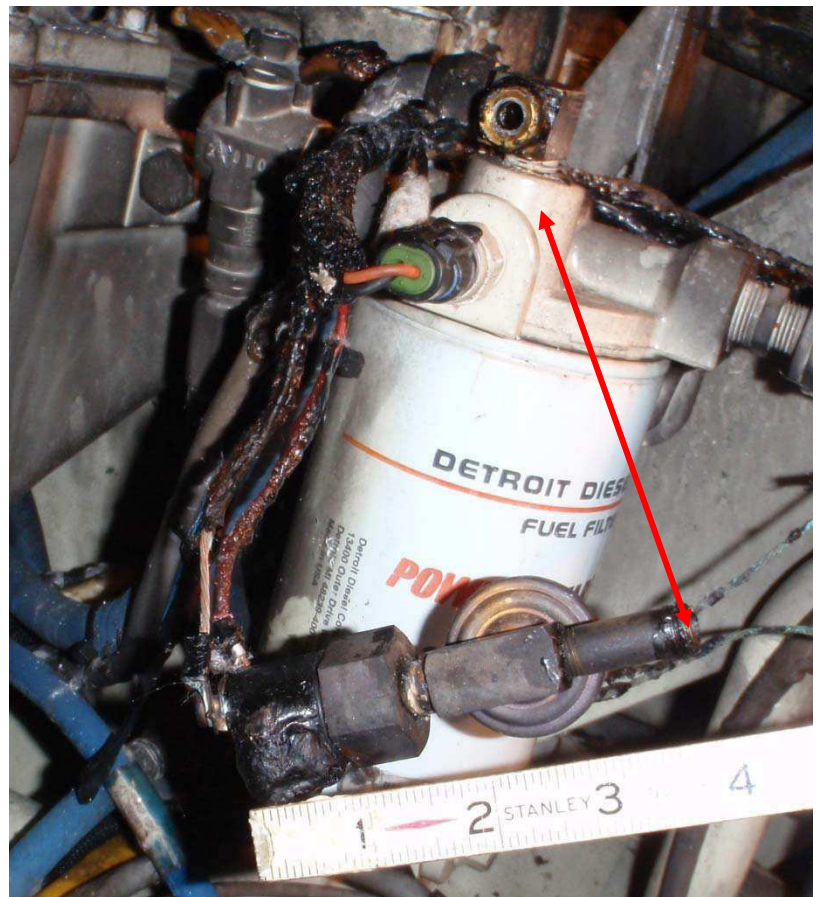
As stated previously, the investigation into this casualty is not yet complete. The components of the pipe fitting which failed are currently being examined by NTSB metallurgists. It is suspected however that the failed fittings may have been subjected to excessive vibration which could have caused the fracture. The original configuration was modified by adding a fitting that attached two additional sensors (for a total of four) to the fuel filter assembly and was subject to pressures up to 65 psig or greater. The assembly weighed 6.3 ounces and extended about 4 inches out of a reducing bushing that was threaded into the inlet fitting of the filter. Because of the location of the fire and oil soaked insulation it is

suspected that the fitting leaked first and did not immediately shear as shown in the photo at the right.
