**United States Coast Guard  
Office of Investigations and Casualty Analysis  
Safety Alerts, Safety Advisories, Lessons Learned  
2008-2012**

**United States Coast Guard**  
**Office of Investigations and Casualty Analysis**  
**Safety Alerts, Safety Advisories, Lessons Learned**  
**2008-2012**

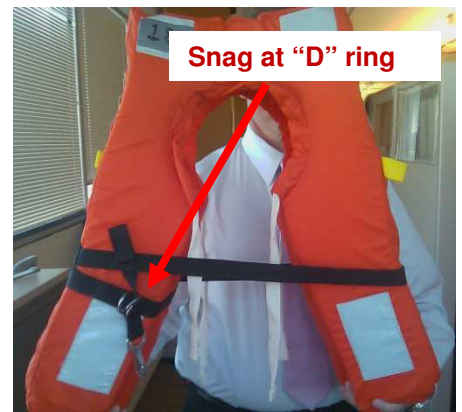
The Coast Guard **strongly recommends** that vessel owners/operators using the PFDs listed above check each lifejacket for proper routing of the strap. Completely unwrap the primary strap to ensure it is free and capable of being adjusted for any wearer. The strap of the lifejacket must not be threaded through the fixed "D" ring. If routing is satisfactory, the strap may be wrapped around the life jacket and clipped to the fixed "D" ring for storage. *(Right image)* If the strap is incorrectly threaded through the fixed "D" ring, the snap hook assembly should be carefully removed from the strap, the strap pulled out of the fixed "D" ring, and the snap hook assembly re-attached.

Vessel owners/operators are also encouraged as part of general preventative maintenance to verify that all their PFDs are in fully serviceable condition with an inspection of the straps, components, fabric and flotation material. Any significant deterioration in condition or poorly functioning hardware indicates a replacement is necessary.

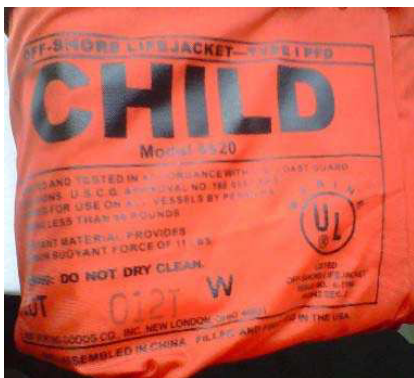
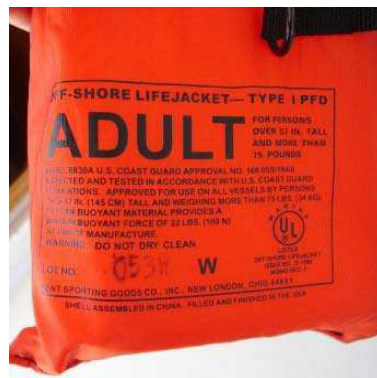
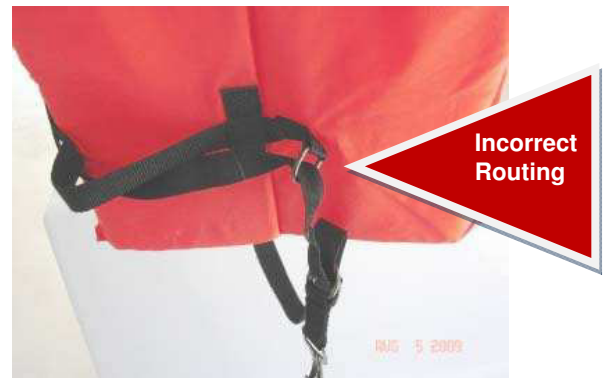
Kent Sporting Goods Lifejackets Shown Above

Kent Child Model 8820 (USCG Approval Number 160.055/150/0) in Lot 012T manufactured in March 2008

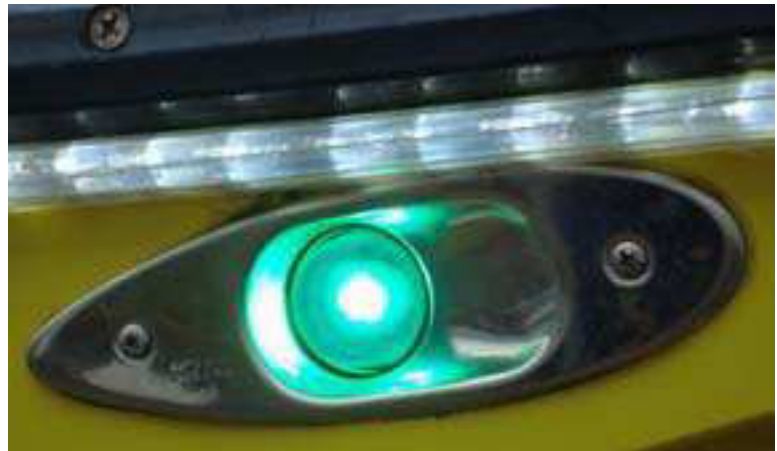
The Coast Guard recognizes that many vessel owners choose to place decorative lights onboard their vessels during the Holiday season. The Coast Guard **strongly reminds** vessel owners not to illuminate such lights during routine navigation unless operating in a Holiday boat parade or when the vessel is secured dockside. This issue was highlighted during a recent casualty whereby the owner of a passenger vessel had installed decorative Holiday type LED (Light Emitting Diode) lighting around the periphery of the vessel. The LEDs were contained in a clear flexible hose and securely attached. Near the bow of the vessel the lighting was adjacent and slightly above the port and starboard navigation lights. At night this installation, can impair the "distinctive character" of the navigation lights as set out in Rule 20 of the Navigation Rules. (Photograph below shows daytime view.)

Additionally, Rule 22 of Navigation Rules states that vessel sidelights have a two mile range for vessels 12 meters or more in length but less than 50 meters in length. In this particular casualty a side light navigation fixture was found installed on the passenger vessel that was stamped 1 nautical mile vice two miles. Vessel owners and operators and marine inspection personnel should ensure that the proper navigation lighting fixtures are installed, that all components operate correctly and that regulatory requirements with respect to Navigation Lighting are met.

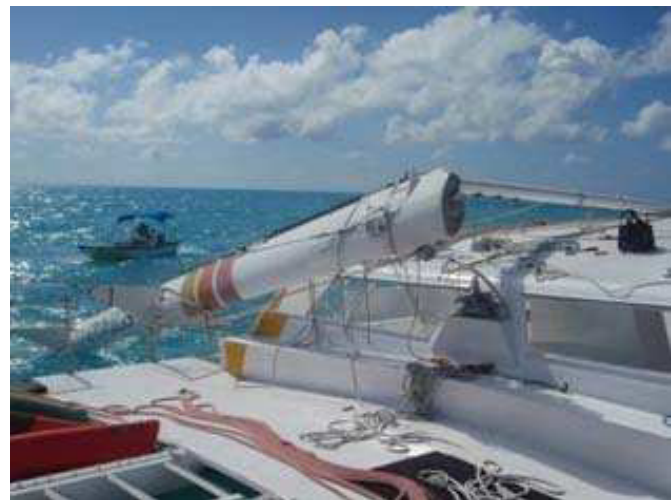
Common among the dismasting casualties was the failure of the mast's standing rigging. While this investigation is ongoing, initial forensic metallurgical analysis of the failed cable strands showed visual corrosion and evidence of fatigue failure. The shroud cable and swageless end fitting had been installed seven years prior.

The Coast Guard **strongly reminds** all commercial vessel owners/operators, especially those of passenger carrying sailing catamaran's of similar build, of their responsibility to maintain their vessels, associated equipment, systems and components in a satisfactory condition suitable for their employed service at all times. Owner and operators should not wait until regularly scheduled Coast Guard inspections to identify problems but should be ever vigilant and implement routine inspection, maintenance, and repair procedures in accordance with good marine practice and in alignment with applicable requirements. Owners and operators should consult the vessel manufacturer or other naval architecture, marine engineering services or qualified rigger regarding any concerns they might have regarding the regular flexing and working of their vessel's standing rigging

Inspection requirements for small passenger vessels are found in 46 CFR 175-185. Additionally, Coast Guard Sector Honolulu, by consensus with their local sail vessel industry, developed Inspection Note #13 that outlines an enhanced inspection regime for sailboat rigging, masts and associated components for their inspected small passenger sailing vessel fleet consisting almost entirely of catamarans. This information is useful to both marine inspection personnel and vessel owners/operators and is available by searching the web using the key words: "Sector Honolulu Inspection Note #13". Manufacturer published guidelines on mast and rigging system maintenance can be found in "Rigging Service Guidelines" <http://www.navtec.net/docs/RiggingService.pdf> published by Navtec Rigging Solutions. Practical standing rigging inspection information from a marine surveyor's perspective is available at <http://www.dixielandmarine.com/yachts/DLrigprob.html>.

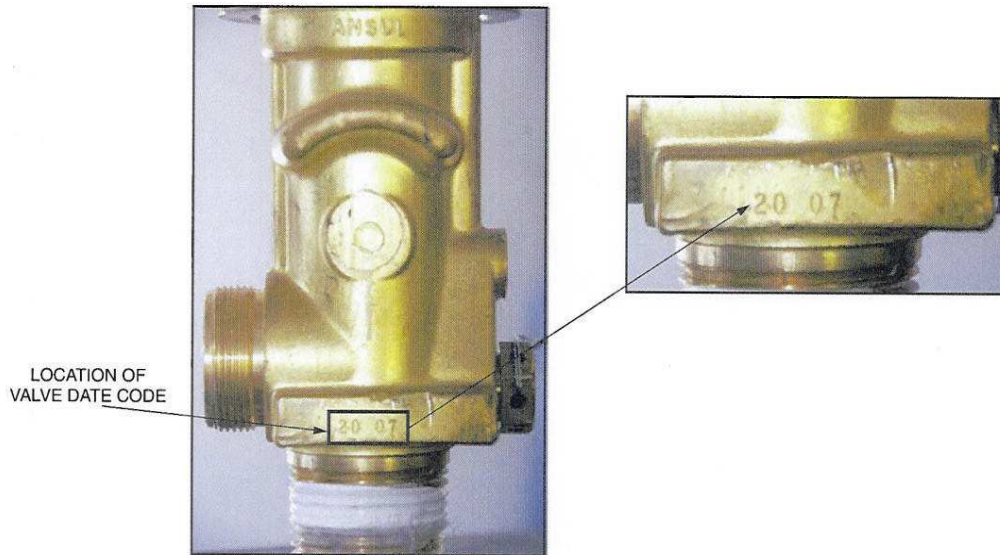
**Marine High Pressure CO<sub>2</sub> valves with a date code range of 10-07 to 06-08.**

This date code range is conservative and may be further narrowed through additional testing. The date code is located on the flat opposite of the valve outlet. The date code represents the week and year the valve was manufactured.

Carbon dioxide cylinders which are installed, or could be installed on a ship with a valve date code between 10-07 and 06-08 **MUST** be identified. If you identify cylinders with valves in this date code range, please contact ANSUL Quality Assurance **IMMEDIATELY** for further information and authorization for replacement of these cylinders.

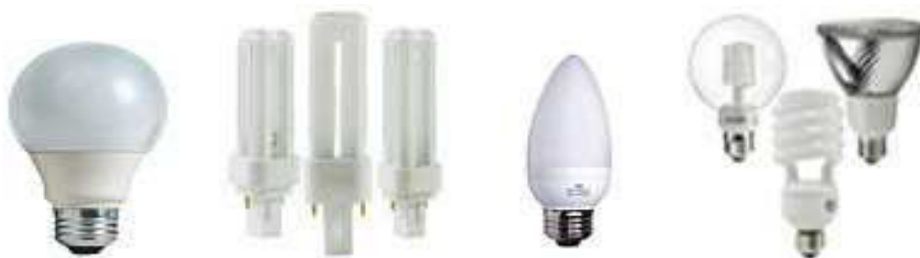
The Coast Guard has learned that CFLs have been installed on the navigation bridges of vessels and in other places capable of causing radio communications interference. Marine inspectors, vessel owners and operators **should be aware** of this potential safety hazard and take proper action as needed.

Below are examples of some compact fluorescent lights with different shapes and sizes.

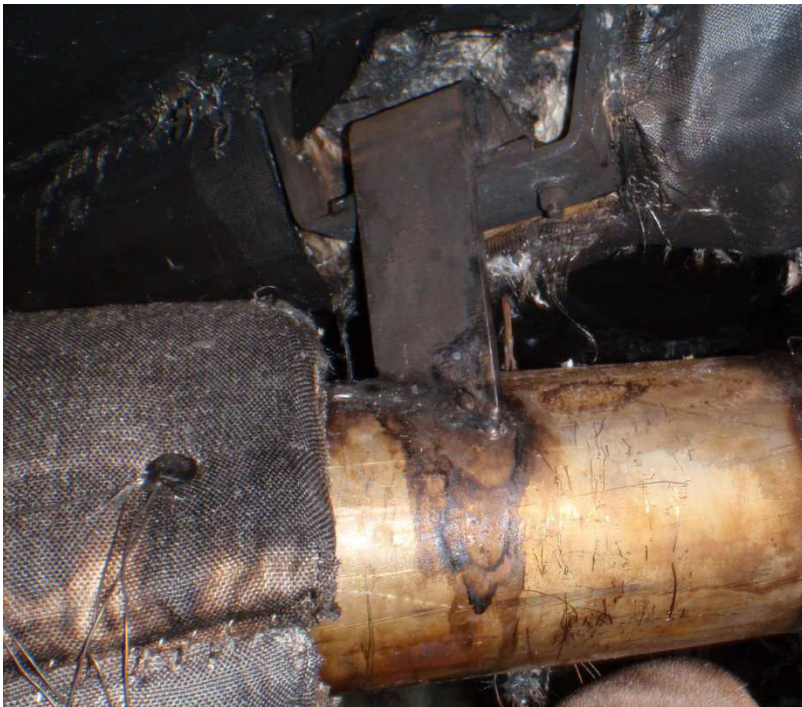
## Hot Spots

In a small engine room containing several engines and having a low overhead there are a number of locations that present enough heat to cause a fuel to flash and ignite other components. Turbocharger and exhaust piping insulation while serving to reduce heating of external areas also helps reduce the immediate availability of ignition hot spots. Care should be taken to ensure insulation wraps and blankets are kept tight and fastened in a manner to prevent dripping or spraying fluids from traveling to an exposed hot spot. Insulation seams should be made tight and where possible aligned in a manner to prevent pooling of fluid and to repel dripping. Likewise good marine practice may also dictate and ensure that braces which are welded directly to the exhaust pipe which serve as hangers or supports

also be insulated. Heat conducting from the exhaust pipe to the brace could be substantial allowing the exposed bracket to become nearly as hot as the exhaust pipe. The brace in the photo above was only partially covered with the insulation that was wrapped around the exhaust pipe. As with the other concerns in this document, owners and operators of any type vessel, as well as those persons involved with the inspection of vessels should be aware of the potential risks associated with improper or inadequate installation of insulation.

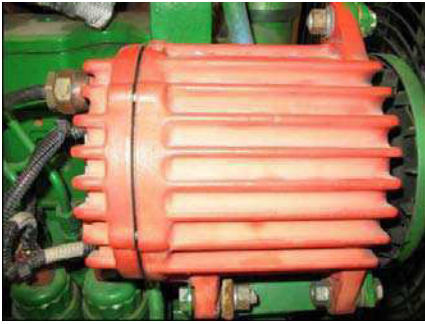
See the photographs below for examples of electrical components on electronically-controlled pump engines that should be examined, repaired or replaced. All electric starters should be removed and replaced with a hydraulic starter with a manual hand pump, or a pneumatic starter with the air compressor located in a non-hazardous location.

Until complete retrofit packages are designed and approved for these engines, vessel operators and OCMI's should take immediate steps to eliminate the risk by ensuring all electrical components on tank barges are in sound and serviceable condition, and those components that are not suitable for hazardous locations are replaced as soon as possible.

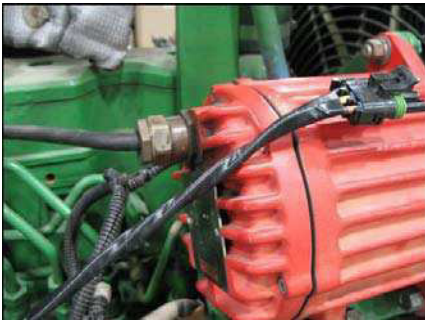
Typical flame proof /explosion proof alternator.

In some installations, cables between the alternator and battery were cut and a connector put in place to allow easier servicing. This alteration is not appropriate for hazardous locations. The cable seal on this alternator may not be the one approved for the alternator and may have to be examined.

**Alternators:** If an alternator is used, it should be an approved flameproof or explosion proof alternator.

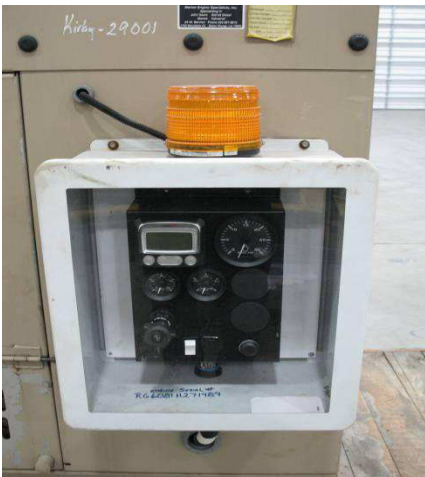
Typical unacceptable electronic display. This is not in an explosion proof enclosure. The beacon installation shown here outside of the enclosure is also unacceptable.

**Electronic displays** should be enclosed in explosion proof enclosures.

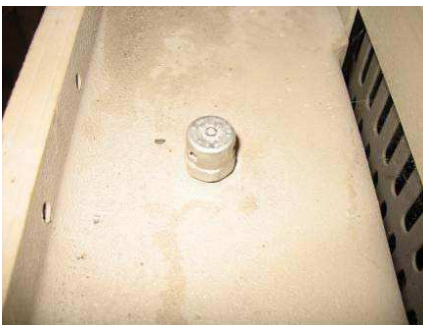
An acceptable engine control unit (ECU) enclosure is shown here with a sealing compound installed in a proper cable gland. Sealing compound poured in the conduit or cable seal fitting should surround each individual insulated conductor and the outer jacket of the cable, unless the cable is gas tight. Cables should be prevented from being pulled out of the conduit or cable seal fitting.
